INITIAL PROTOTYPE EVALUATION OF EXPANDABLE CARCASS-REPLACEABLE TREAD TIRE FOR C-130 AIRCRAFT

THE B.F. GOODRICH COMPANY
AKRON, OHIO 44318

JANUARY 1975

TECHNICAL REPORT AFFDL-TR-74-131

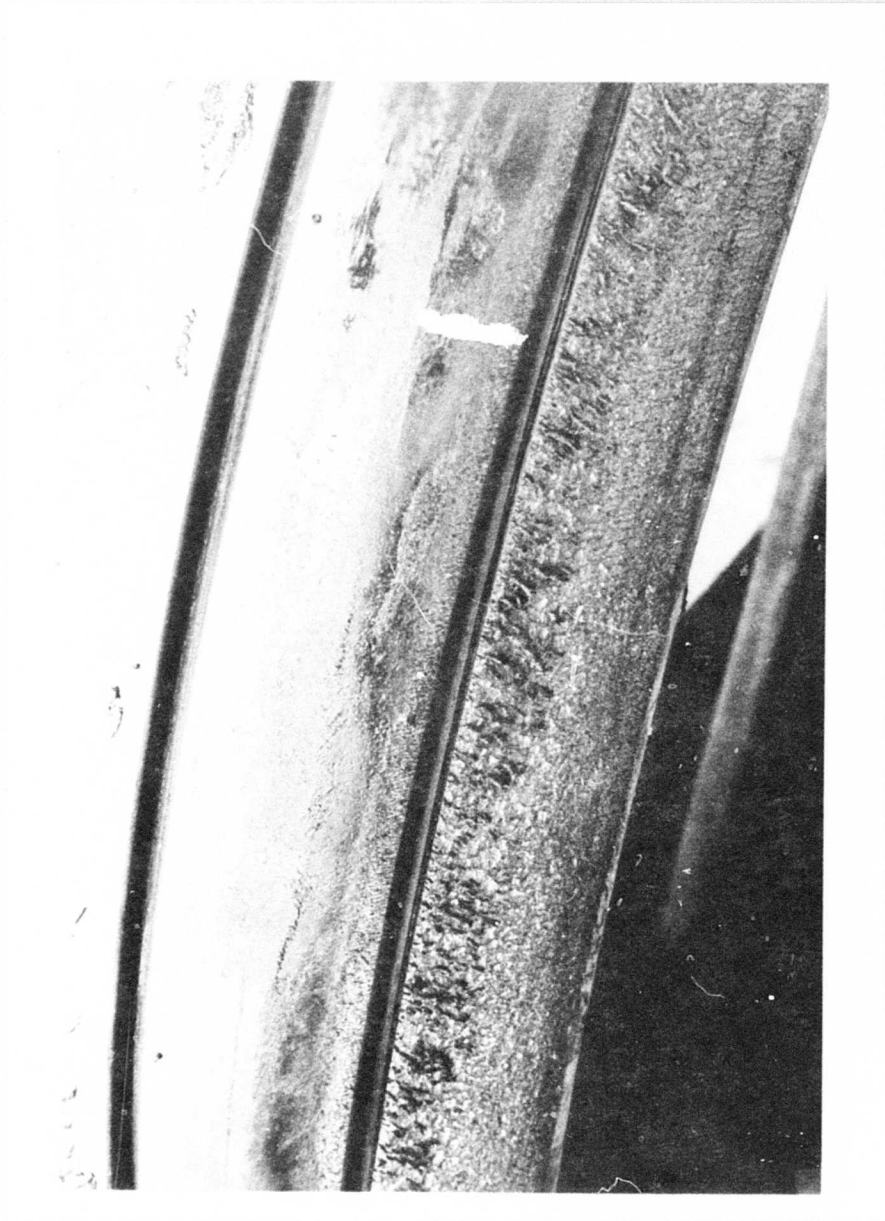
Figure 10. Photograph of Outside of 20.00-20/26 PR Tread Band Showing Abrasion Along One Edge.

as seen in Figure 9. We concluded that the tread band was moving on the carcass, probably when going through the footprint. The outside surface of the tread band also showed severe abrasion at both edges. See Figure 10. At this point we did not know whether the abrasion on the outside of the tread band was related to the chafing at the interface of the carcass and tread band.

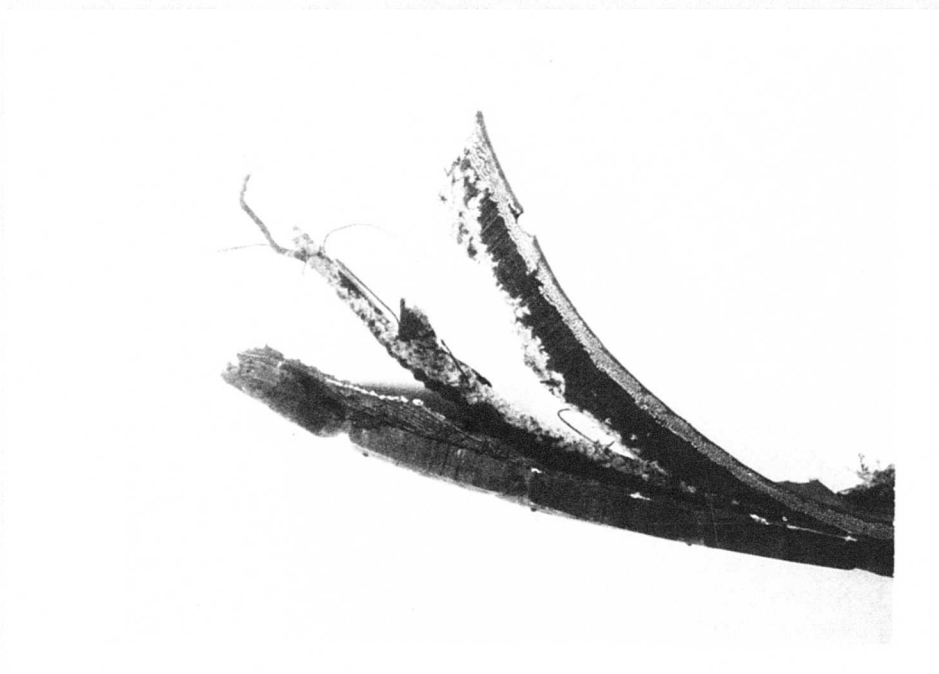
Figure 15. Closeup Photograph of a Cross-Section in a Modified Tread Band After Tensile Failure.
